Five-Year Review Report

**Former Simpson Remanufacturing Facility
Arcata, California**

Simpson Timber Company

March 2005
003154

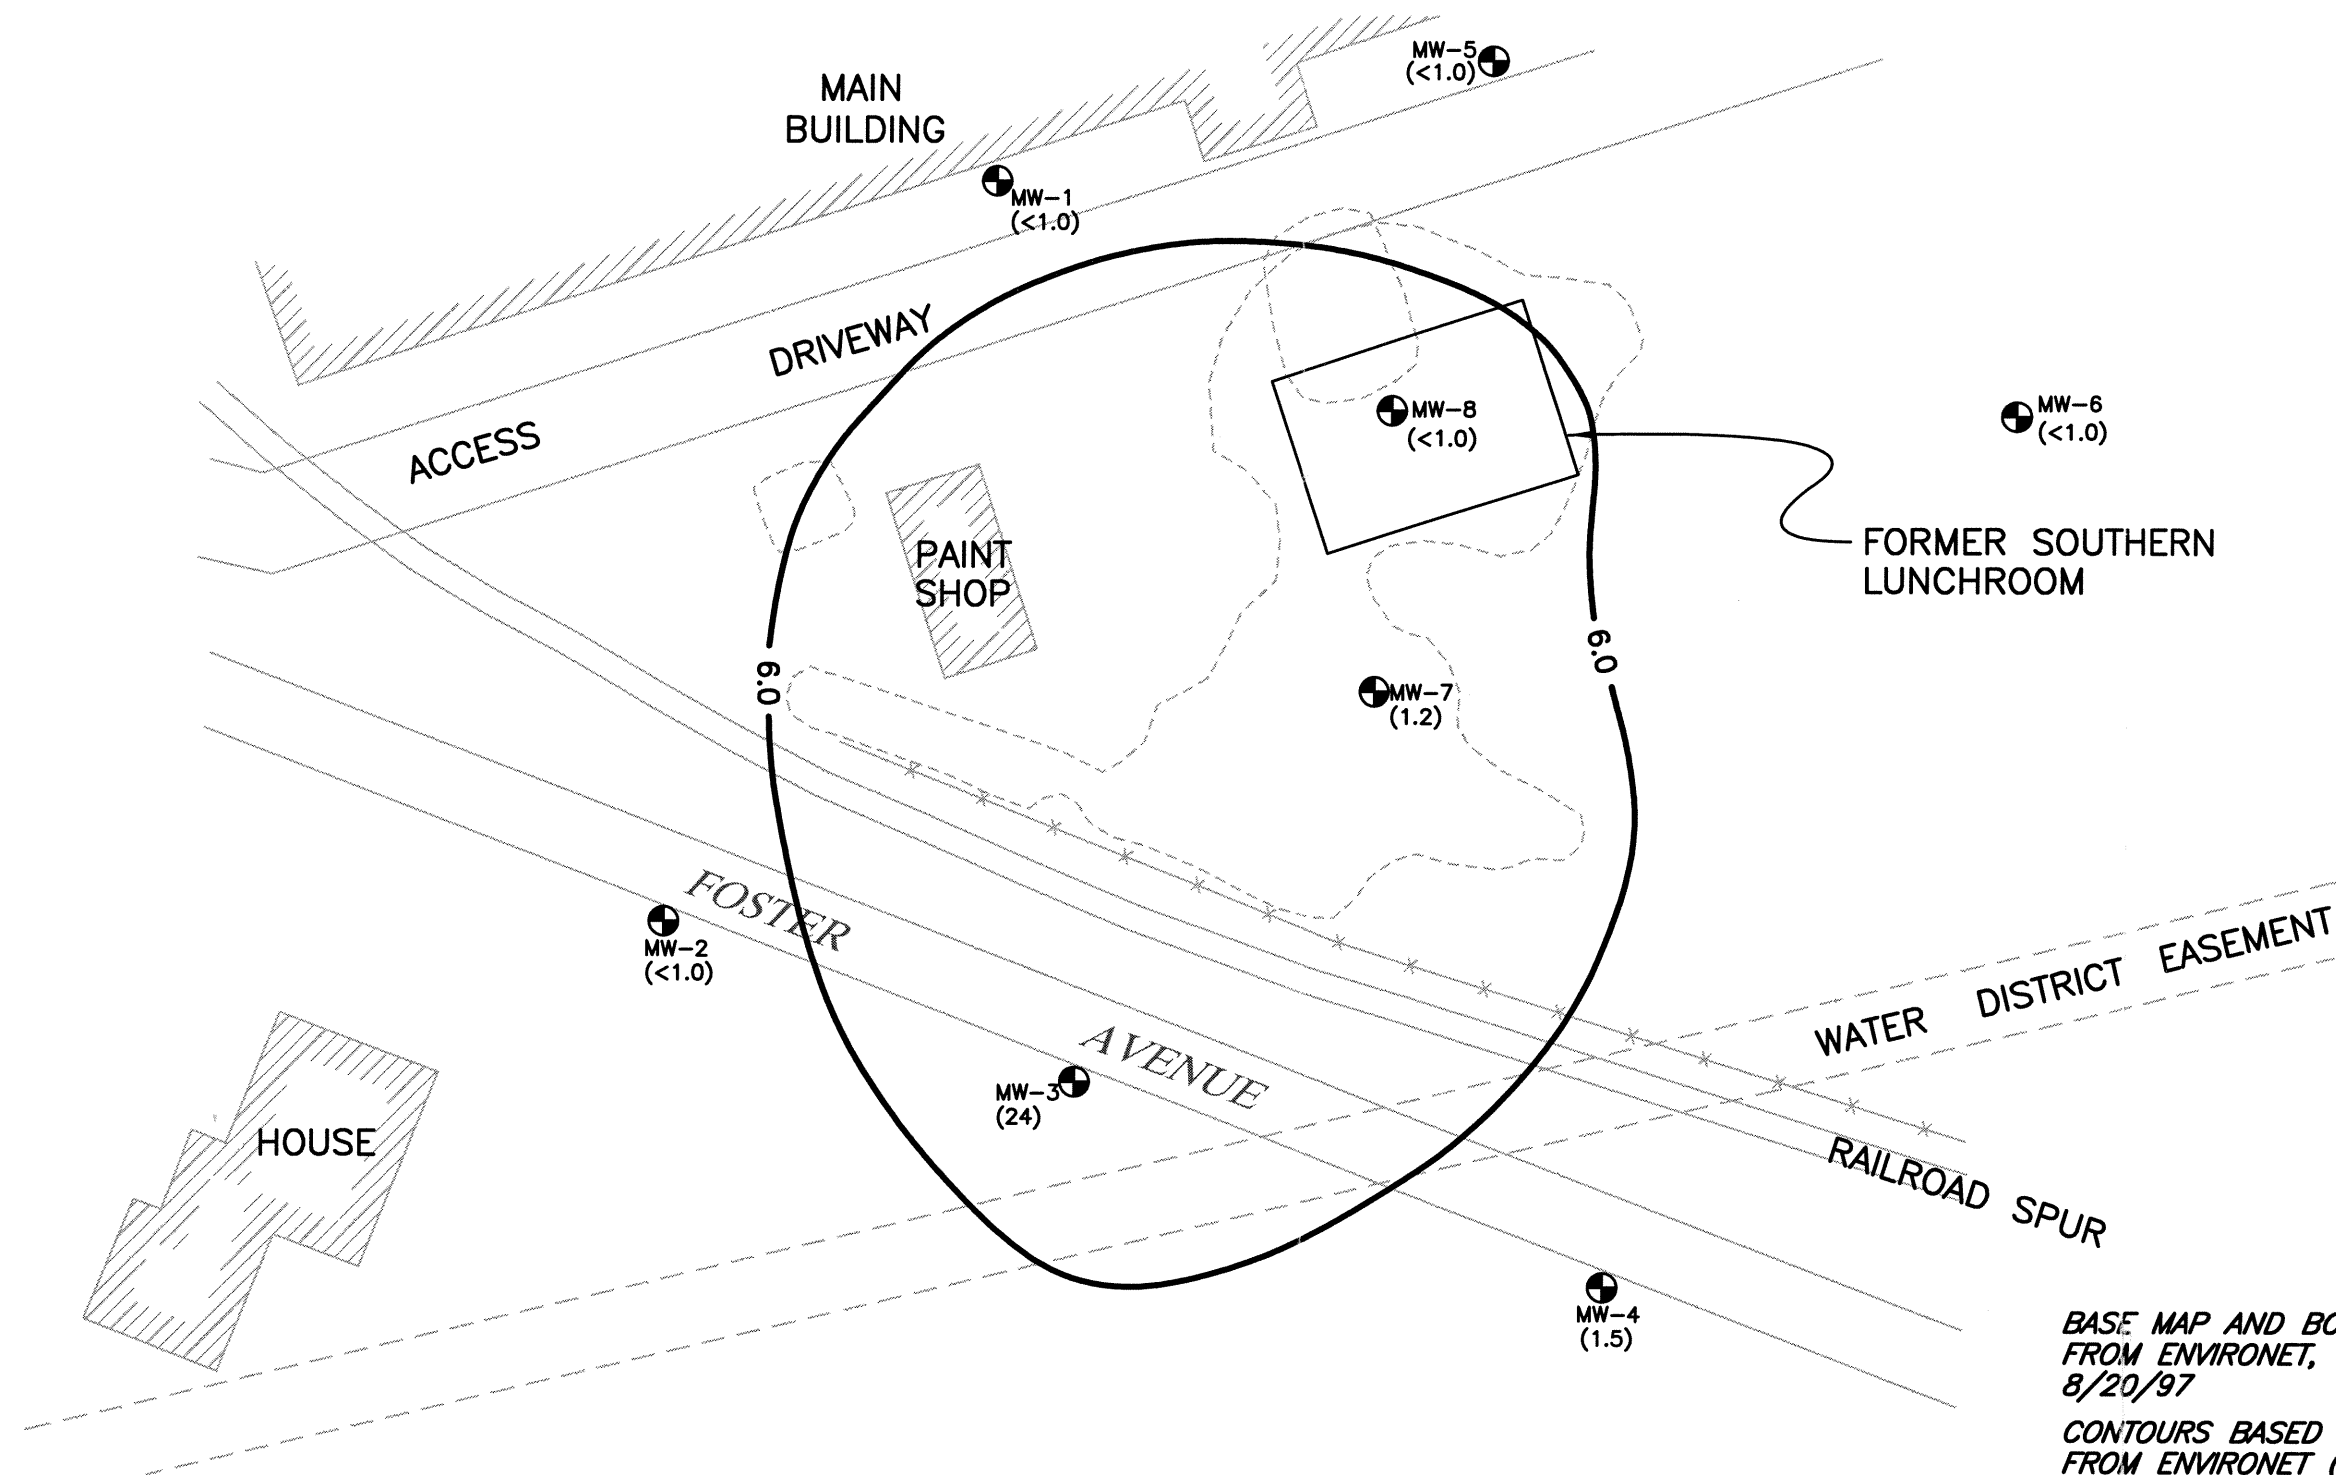
Figure 3

In January 2004, SHN conducted additional site investigation in the former SLR area. As previously discussed, VOCs, primarily cis-1,2-DCE, trans-1,2-DCE and vinyl chloride, were found

A review of groundwater information collected from the area of the southern lunchroom (wells MW-7 and MW-8), and downgradient of the southern lunchroom (well MW-3) indicates that the VOC contaminant plume is slowly migrating offsite. Biodegradation indicator monitoring information indicates that the VOC plume is degrading, as evidenced by the presence of cis-1,2-DCE, trans-1,2-DCE and vinyl chloride, all of which are breakdown products of PCE and TCE.

Southern Lunchroom Area. Based on the limited extent of VOC contamination in the area downgradient of the former southern lunchroom, it is recommended that a Monitored Natural Attenuation (MNA) program be implemented for this area. As part of the MNA program, groundwater monitoring would be continued in order to monitor the VOC plume over time. This program would be conducted for a period of one year, at which time, the data would be evaluated, and recommendations would be made for future activities at the site. SHN recommends that groundwater monitoring be conducted on a quarterly basis. During each quarterly event, each site well would be measured for depth to water. Prior to purging, wells MW-2, MW-3, MW-4 and MW-7 would be measured for dissolved oxygen, dissolved carbon dioxide and oxidation-reduction potential. Wells MW-2, MW-3, MW-4 and MW-7 would then be purged and sampled. Each groundwater sample would be analyzed for:

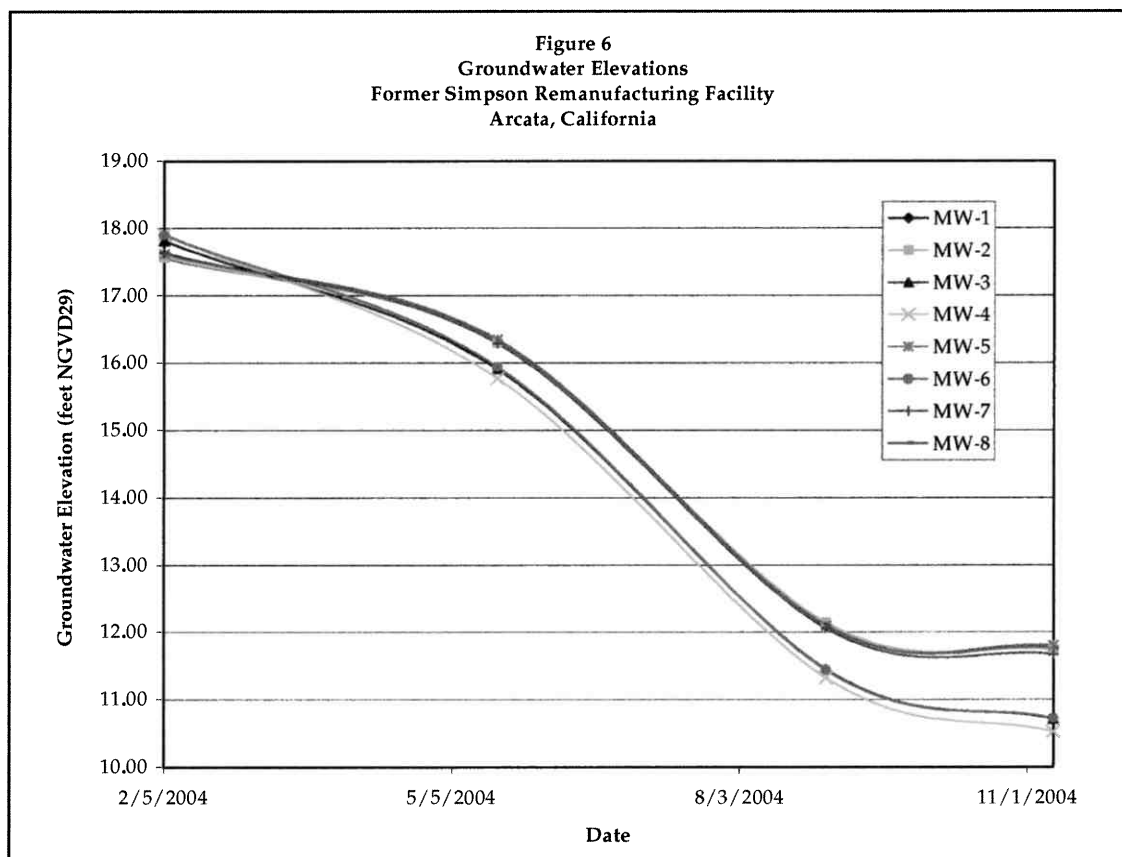
Depth-to-groundwater measurements were collected from all wells during each quarterly monitoring event. The direction of groundwater flow varied during the four quarterly monitoring events. On February 5, 2004, the groundwater flow direction was to the northwest, on May 19, 2004 to the southeast, and to the south-southeast on August 30 and November 9, 2004. Groundwater gradients varied from 0.0015 to 0.008, with an average gradient of 0.0044. Figure 6 shows the hydrograph from the four monitoring events.

Although the water level data collected in February 2004 indicated that the direction of groundwater flow was to the northwest, a review of the hydrograph in Figure 6 shows that the dominant direction of groundwater flow is in a southeastward direction. The hydrograph in Figure 6 also shows that the highest groundwater gradients are present when groundwater flow is in a southeastward direction. Groundwater elevation data collected in 2004 is presented in Attachment 4.

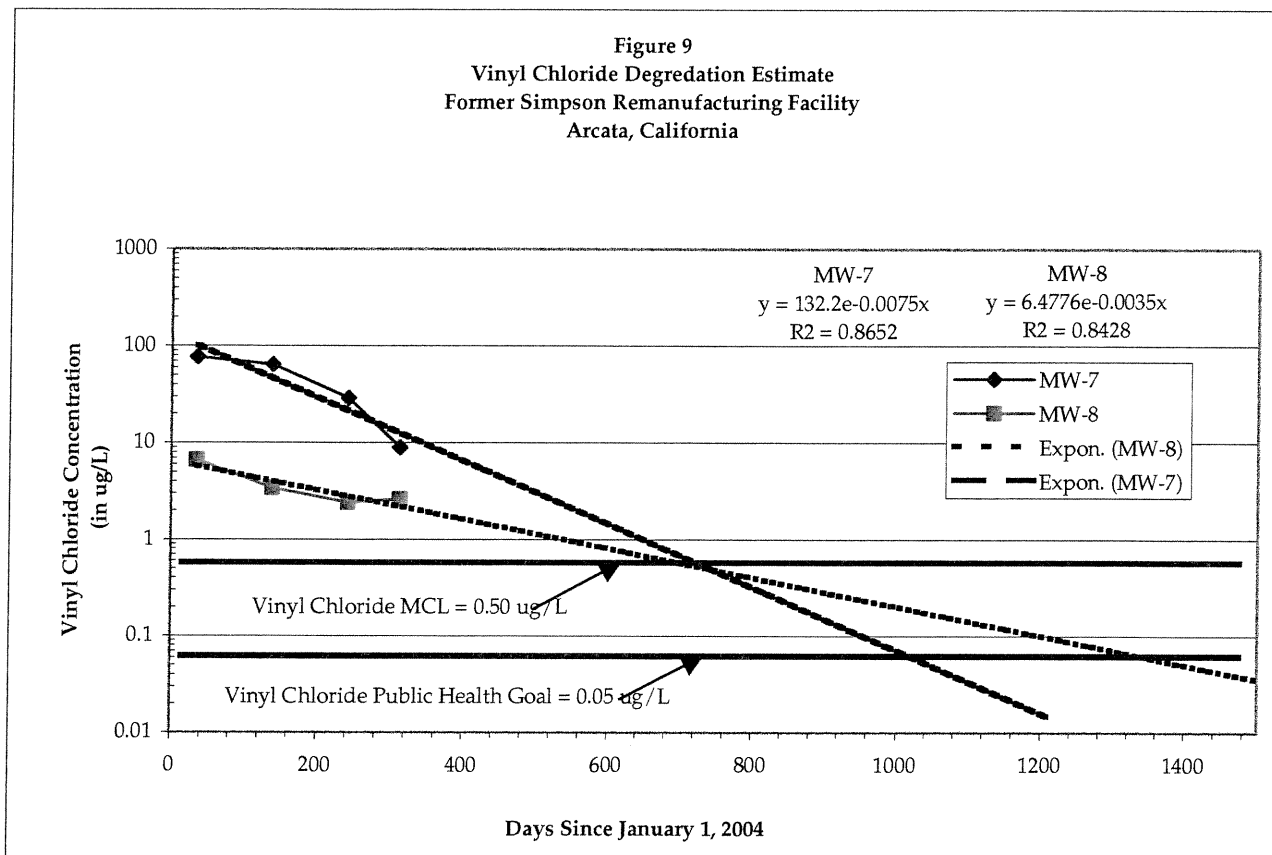
In general, DCE degrades via sequential reductive dechlorination to vinyl chloride and then to ethane (Wiedemeier, 1998). Cis-1,2-DCE and vinyl chloride are still present at low concentrations in select wells at the SLR. Concentrations of cis-1,2-DCE show a decreasing concentration trend in well MW-7, but are not decreasing in well MW-3 (Figure 8). Vinyl chloride concentrations show decreasing trends in wells MW-7 and MW-8, while the trend for well MW-3 is slightly increasing (Figure 9).

Concentrations versus time rate constants are used for estimating how quickly remediation goals will be met at a site (Newell et al., 2002). The rate constants are derived from plotting the concentration of the contaminant versus time, fitting a best-fit line to the data, and calculating the slope of the line. The rate constant is then used to estimate when a particular water quality goal will be achieved. These procedures are detailed in *Calculation and Use of First-Order Rate Constants for Monitored Natural Attenuation Studies* (Newell et al., 2002). These procedures were used to create the estimated timeframe when Vinyl Chloride would reach water quality goals in wells MW-7 and MW-8 (Figure 9). Data from well MW-3 could not be used as both cis-1,2-DCE and vinyl chloride show increasing concentration trends. Concentrations of cis-1,2-DCE in MW-7 have been consistently below the DHS MCL of 6.0 ug/L. The data plots indicate that the DHS MCL of 0.5

ug/L for vinyl chloride in wells MW-7 and MW-8 will be reached in approximately two years from January 1, 2004. Likewise, based on a start date of January 1, 2004, the data plots also indicate that the California Office of Environmental Hazard Assessment Public Health Goal of 0.05 ug/L would be reached in approximately 3 years in well MW-7, and in approximately 4 years in well MW-8.
